TB-164372 07 NOV 2022

Product:	Ghost
Product Description:	24/36v Ghost Trolling Motor (All Models)
Serial Range:	120784377 and below
Effective Date:	07 NOV 2022
Inspect/Update Current Inventory:	Yes

## Ghost Over Current Protection – Alternate Wire Routing

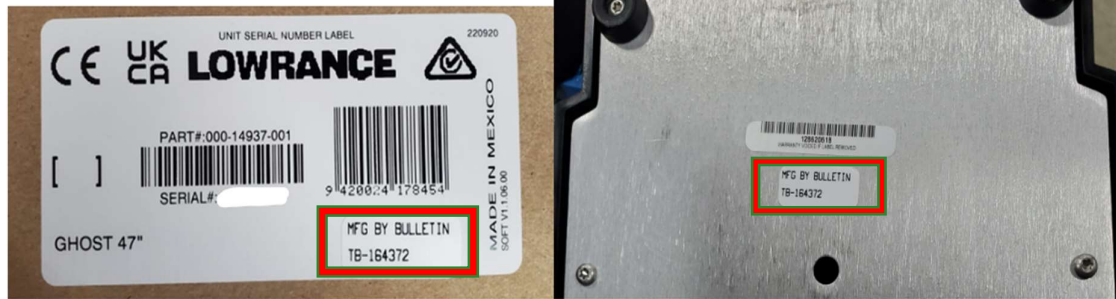
Fig 1

Motors that have been assembled to these specifications can be identified by the sticker on the bottom of the foot pedal and on the outside of the box as shown in Fig 1.
